Hydraulic Ram Repair

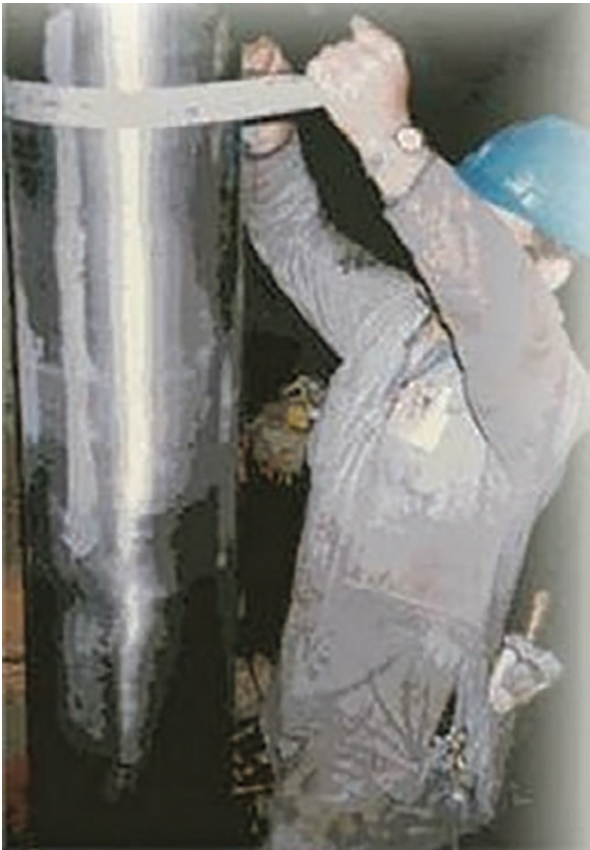
This hydraulic cylinder on an automotive assembly line hoist was scored and pitted causing loss of hydraulic oil, efficiency, and a hydraulic fluid puddle that could lead to a trip/slip/fall hazard.

The area was degreased with [USI Universal Cleaner](#) and the rods were heated to “sweat out” any absorbed oil. After another cleaning with [USI Universal Cleaner](#), a series of holes were drilled along the score marks to add surface area along with “V” cut for proper adhesion.

[RESIMETAL 101 Metal Repair Paste](#) was applied, and a profile template was used to remove excess material. After curing, the original profile was restored with wet emery paper.
