Detroit Utility Steam Tunnel

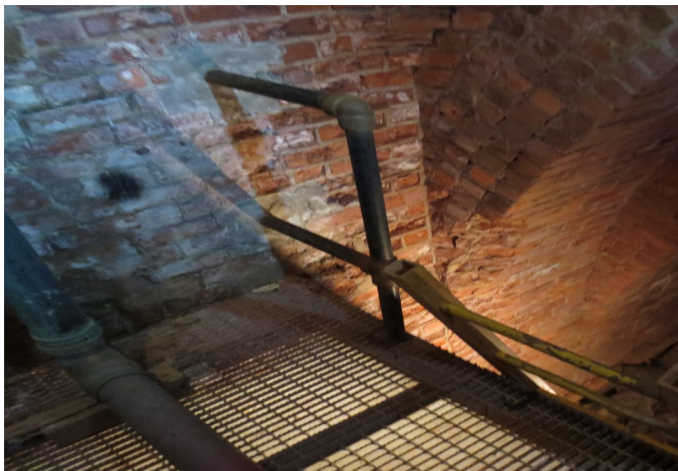
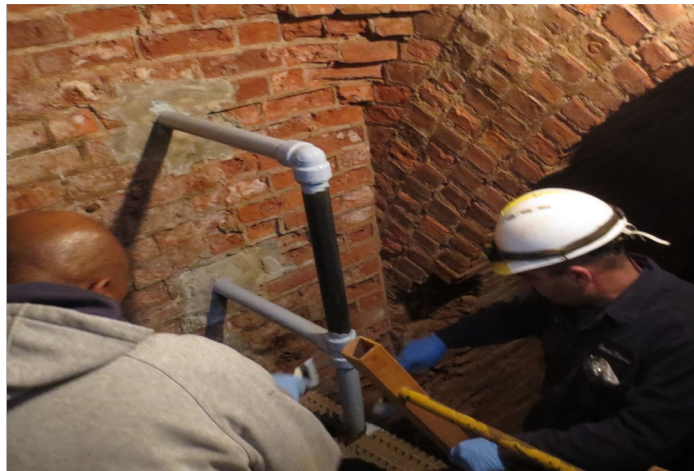
This Detroit utility steam tunnel can reach 220°F with constant humidity. Because of the harsh environment, they have been coating the railings on a weekly basis with a competing product.

They were looking for something that would last longer than a week or two costing a great deal of time and money. These tunnels see constant humidity and high heat which increases the corrosion rate by over 50% when compared to ambient temperatures. We presented them with an option that they were very excited to try.

We first prepped the railings with a wire brush to remove all loose debris, previous coatings and rust. We then brushed [RESICHEM 501 CRSG](#) onto the existing steel surface.

[RESICHEM 501 CRSG](#) can be used with manually applied applications with 100% humidity. It has been tested to 10,000 hours of salt fog and has been successful in many other applications throughout the Midwest and Great Lakes regions.

This can provide a 15–25-year coating in the extremely harsh environments. The customer is very pleased and looking forward to the extra time they will have now that they don't have to do weekly maintenance.
